**NASA TM X-73988**

**EFFECT OF LOW VELOCITY IMPACT DAMAGE ON THE COMPRESSIVE STRENGTH  
OF GRAPHITE/EPOXY HAT-STIFFENED PANELS**

**Marvin D. Rhodes, Jerry G. Williams, and James H. Starnes, Jr.**

**December 10, 1976**

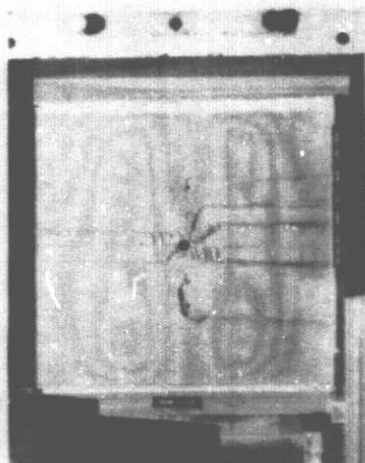
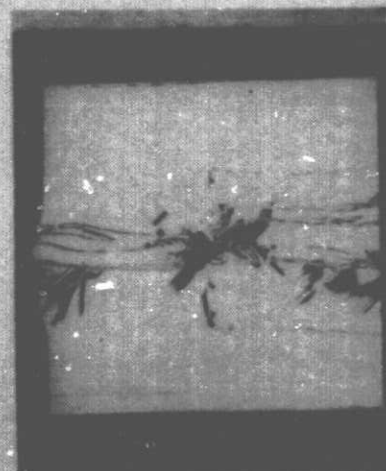
Figure 6.- Photographs of moiré fringe patterns of Panel B5 at several values of applied axial strain,  $\epsilon_a$ .

At applied strains near 0.0049 large changes in strain were recorded near the cutout and noticeable panel displacements began to develop in the vicinity of the cutout. Moiré fringe patterns representing the normal displacement-field near the cutout are shown in figure 6 for several values of applied strain. A representative moiré fringe pattern for an applied strain of 0.0048 is shown in figure 6a and a close up of the cutout region for this applied strain is shown in figure 6b. At an applied strain of approximately 0.0049 a local buckling displacement field began to develop at the cutout edge about  $60^\circ$  counterclockwise from the loading axis. This displacement-field was about 1.0 cm long for an applied strain of 0.0050 and is shown in figure 6c. As the applied strain was increased, the extent of the displacement-field increased to a length of about 1.8 cm for an applied strain of 0.0055 as shown in figure 6d. At an applied strain of 0.0057, the displacement-field had rotated counterclockwise to a position  $90^\circ$  from the loading axis (figure 6e) and extended on both sides of the cutout. This displacement field extended about 2.5 cm on the left side and about 2.4 cm on the right side of the cutout which makes the total length of this displacement field approximately equal to the width of the  $0^\circ$  fibers in the skin under the stiffener. The local displacement-field propagated across the panel (figure 6f) at an applied strain of 0.0058 which indicates that the local behavior precipitated panel failure.

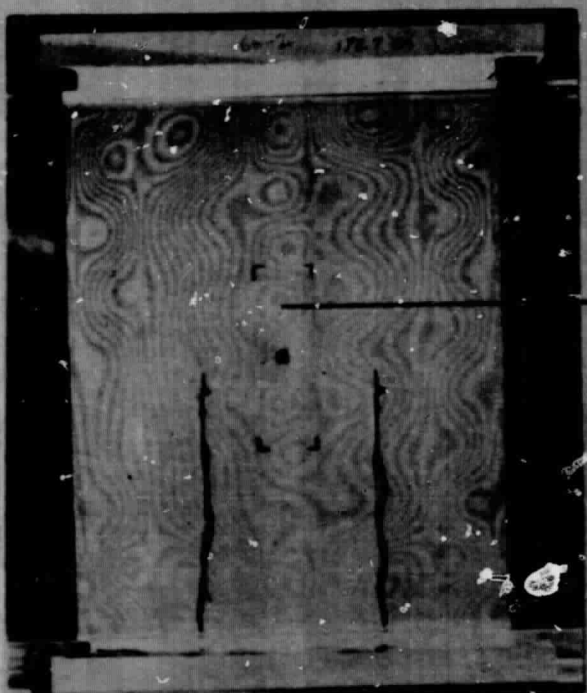
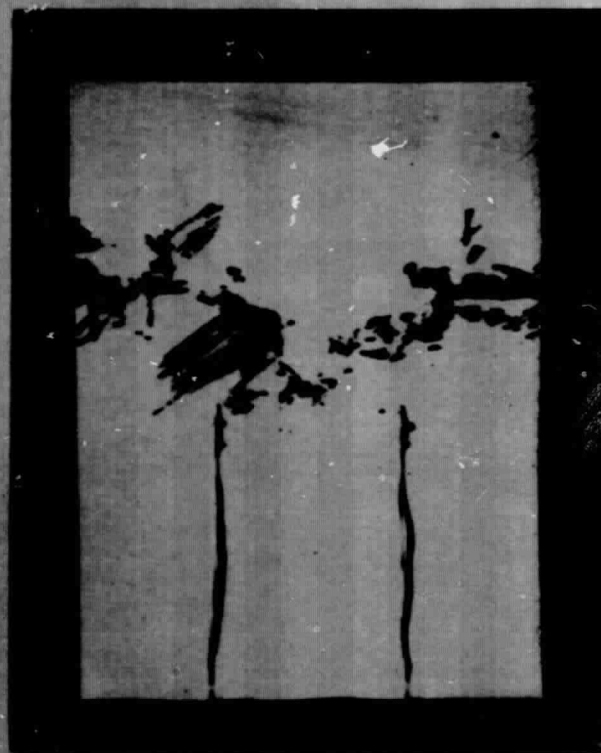
Figure 7.- Panel A4 after impact in the high axial stiffness region while at zero applied axial strain.

Low axial strain at impact.— Test panels A4, A5, and B6 were damaged by impact with a small axial load applied at the time of impact (see table II). A visual examination of the area where impact occurred revealed no apparent local damage. All three specimens were subsequently loaded in compression to failure. Several strain gages away from the impact region were used to monitor the applied axial strains. The average of these gages is subsequently referred to as the applied strain. The applied strain at failure for all three test panels is given in table II. Both panels A4 and A5 failed at applied strains near their design strain level (0.0034). A photograph of the moiré fringe pattern of panel A4 loaded prior to failure and a photograph of the failed panel are shown in figure 7. The moiré fringe pattern (figure 7a) is similar to that of the undamaged panel A1 (figure 3a). The dark spot in the center of the panel is the impact location where the paint has been removed for post impact inspection. Figure 7b indicates that the panel failure region is extensive and includes the impact location. The panel was inspected ultrasonically prior to failure and a photograph of the oscilloscope record for the region in the vicinity of the impact location is shown in the insert of figure 7a. The area represented by the insert is outlined on the photograph. The dark area shown in the insert indicates subsurface damage in the panel. This area is about 6.35 cm long and about as wide as the region beneath the hat which contains 0° plies. The results of tests on panels A4 and A5 were similar.

a) Photograph of moiré fringe pattern of buckled panel at an applied axial strain of 0.0035. Insert shows region of subsurface damage.

b) Test panel after failure at applied strain of 0.0036.

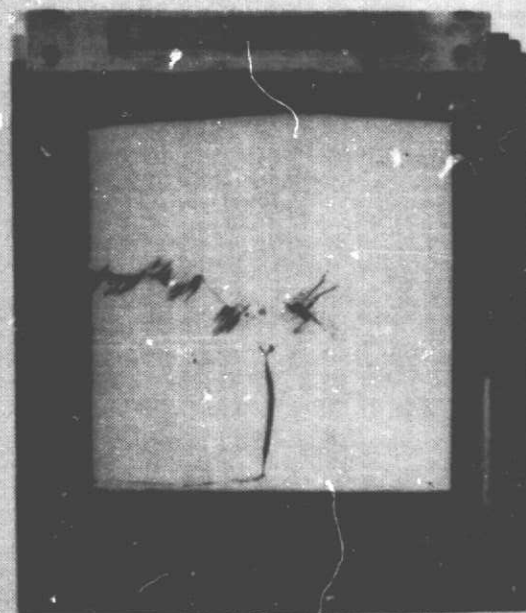
Figure 8.- Panel B6 after impact in the high axial stiffness region while at an applied strain of 0.0003.

Panel B6 failed during the residual strength test at an applied strain of 0.0043 which is about 54 percent of the design value. A photograph of the moiré fringe pattern prior to failure and a photograph of the failed panel are shown in figure 8. A small circular pattern in the region of impact was observed with the moiré fringe technique indicating the presence of local damage. The development of this fringe pattern and an examination of the panel failure indicate that the impact damage precipitated the panel failure.

results were obtained for these two sections. A photographic record of the ultrasonic inspection is shown in the insert of figure 8a. The subsurface damage region is oval shaped and is about 2.54 cm wide by 3.81 cm long. One of the stiffeners was cross sectioned in the region of impact damage and examined microscopically. A photomicrograph of the cross section at a low level of magnification is shown in figure 9. This photomicrograph reveals delamination in the cross section with the most severe delamination occurring on the back surface of the laminate. Striations or hairline crack patterns through the thickness can also be observed. These cracks converge on the point of impact and are similar to those patterns observed for impact damaged glass panels. Both the cracking and the delamination are probably the result of stress waves generated by the projectile impact.

a) Photograph of moiré fringe pattern at applied axial strain of 0.0041 showing the development of a fringe pattern near the point of impact. Insert shows region typical of subsurface damage in a similar test panel.

b) Test panel after failure at applied strain of 0.0043.

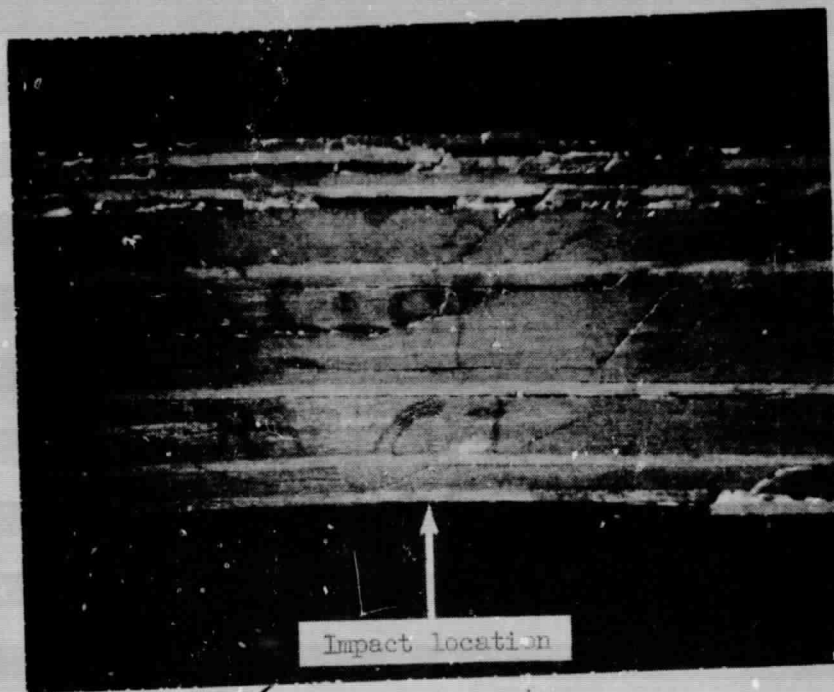
The results of this investigation suggest that impact causes considerable ply delamination, and examination of the panel cross-section showed that the delamination occurred primarily at the interface between the  $0^\circ$  and  $45^\circ$  plies (fig. 9). The discrete layers formed by delamination may not be midplane symmetric and, therefore, exhibit anisotropic coupling effects. The boundaries of these discrete layers are highly irregular (fig. 10) and are subjected to high interlaminar normal and shear stresses. Also, delamination reduces the local cross-sectional bending stiffness and causes locally eccentric loading which introduces transverse shear forces and moments not present in the undamaged panel. These local eccentric forces and anisotropic effects cause local deformations and strain gradients to occur in the delaminated region that could be sufficient to make local geometric and material property nonlinearities important factors. Since these eccentrically loaded layers are thinner and less stiff than the undamaged laminate, they can buckle locally at a lower load than the undamaged laminate. This could cause a local load redistribution in the panel that, in turn, could cause the damage to propagate and the panel to fail. The results of this investigation suggest that highly efficient graphite/epoxy hat stiffened compression panels designed for high strain (0.0080) can exhibit serious degradation due to impact damage, however, efficient damage tolerant designs can be obtained for more moderate strains.

Figure 9.- Photomicrograph of the cross-section of the high axial stiffness region of a panel similar to B6 after being subjected to impact damage at zero applied axial strain.

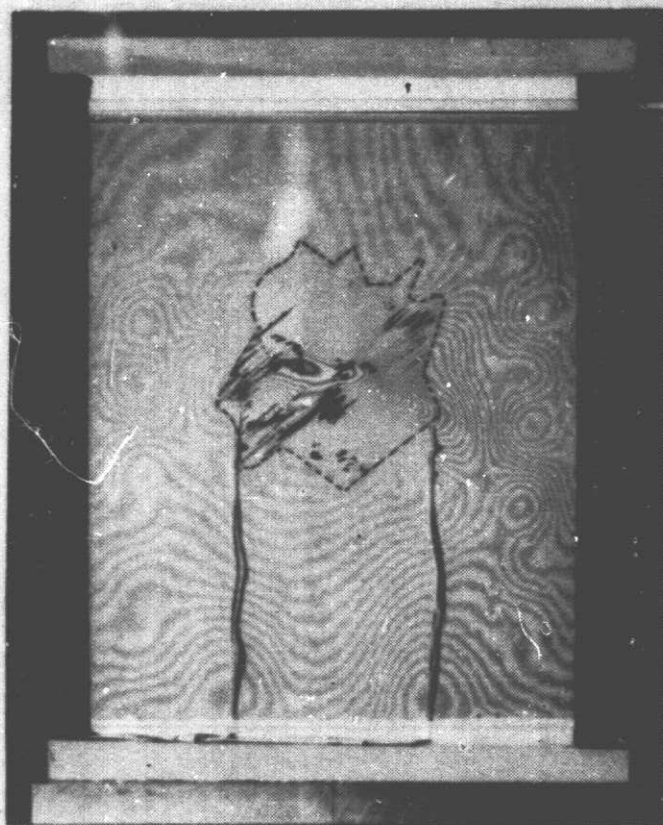
Figure 10.- Panel A3 after impact in the high axial stiffness region while at an applied strain of 0.0034.

High axial strain at impact.- Test panels A3, B7 and B8 were damaged by impact with a high axial load applied (see table II). Panels A3 and B7 which had an applied axial strain of 0.0034 and 0.0030, respectively, had a large region of visually detectable damage in the impact area. Instrumentation monitoring applied load indicated both panels had significant load reductions at impact due to loss in panel stiffness (table II). Both were subsequently loaded to failure to determine the panel residual strength. Panel A3, which was loaded to 0.0034 and damaged by impact, was ultrasonically inspected prior to the residual strength test. An extensive region of subsurface damage was detected. A photograph of the moiré fringe pattern of the panel loaded prior to failure is shown in figure 10a where the subsurface damaged region is outlined. Even though the damage in panel A3 is extensive, it buckled at an applied strain near the design level and carried additional load after buckling similar to the undamaged panels. The panel failed in the region of the impact damage (figure 10b). Comparison of panel A3 with panels A4 and A5, all of which were designed for moderate strains, indicates that the extent of the subsurface damage did not significantly affect the strain level at which the panel failed.

a) Photograph of moiré fringe pattern of buckled panel at an applied axial strain of 0.0031.

b) Test panel after failure at applied strain of 0.0037.

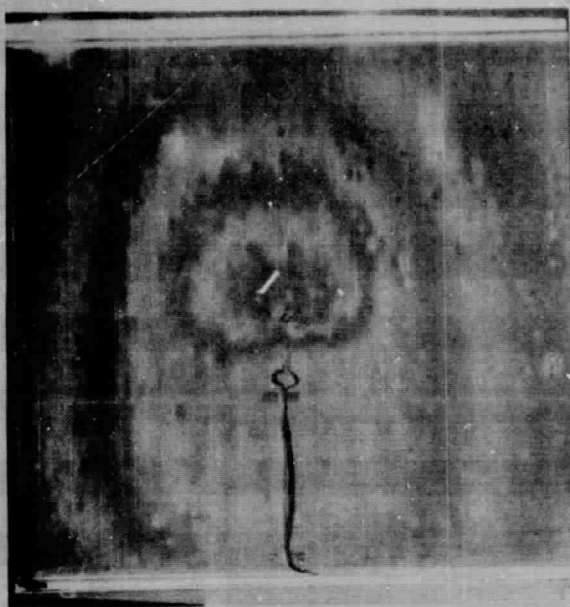
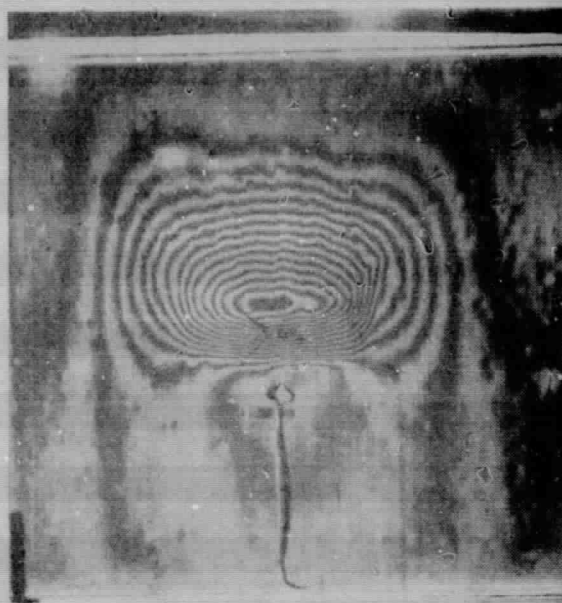
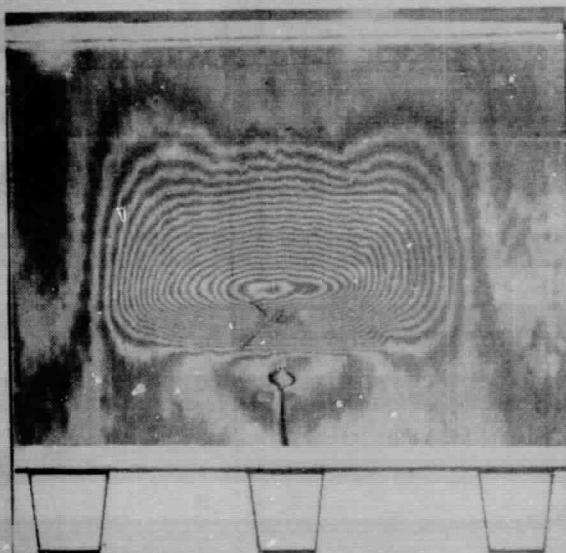
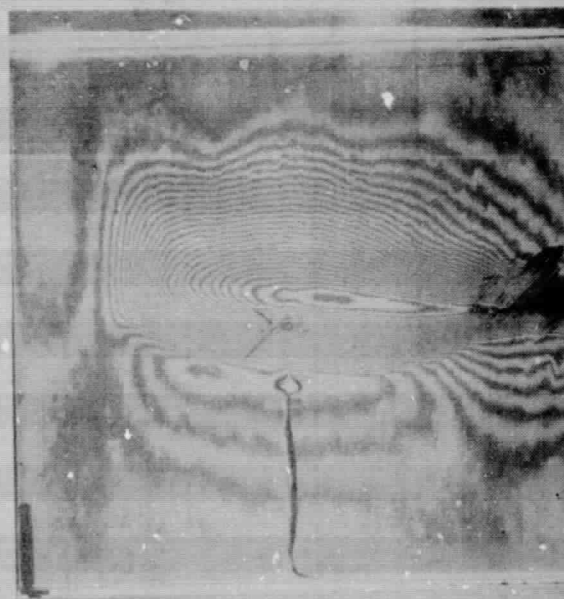
Figure 11.- Panel B7 after impact in the high axial stiffness region while at an applied strain of 0.0039.

Panel B7 failed during the residual strength test at an applied strain of 0.0046 which is about 58 percent of the design value. Several photographs of the moiré fringe pattern taken during the residual strength test are shown in figure 11 along with a photograph of the failed panel. The

moiré fringe pattern shows considerable lateral deformation of the panel center which may be due to impact induced delamination or skin buckling. When the panel was damaged by impact a reduction in applied load of 28.9 kN was measured. This is approximately the load which the high axial stiffness region beneath the center stiffener is calculated to carry for an imposed strain of 0.0030.

d) Panel after failure at applied strain of 0.0046.

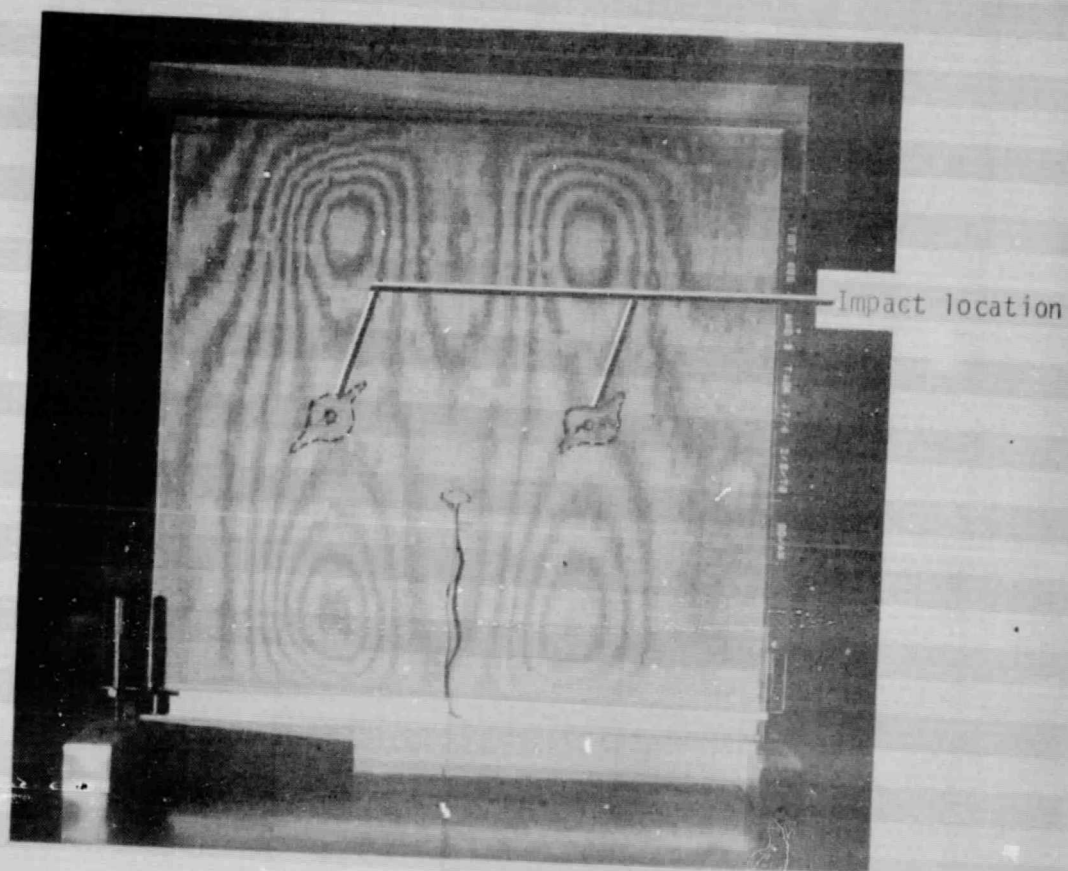
similar to that observed for the undamaged test panel. A local fringe pattern can be seen in the figure at each impact location.

Following this test the panel was inspected ultrasonically to evaluate the extent of the damage region. The subsurface damage region is outlined on the panel in figure 13. The two damaged regions are about the same size which indicates that the magnitude of the applied strain had no apparent effect on the extent of local damage. These results indicate that impact damage in the regions having high axial stiffness is significantly more detrimental than it is in regions of low axial stiffness.

Figure 13.- Photographs of the moiré fringe pattern for Panel B9 at an applied axial strain of 0.0062 with impact damage at two locations in the low axial stiffness region.
